Slope Instability Below Historic Mine Benches in the Northern Coalfields of West Virginia

MUHAMMAD ALI
AARON E. MAXWELL*

Department of Geology and Geography, West Virginia University, Morgantown, WV 26505

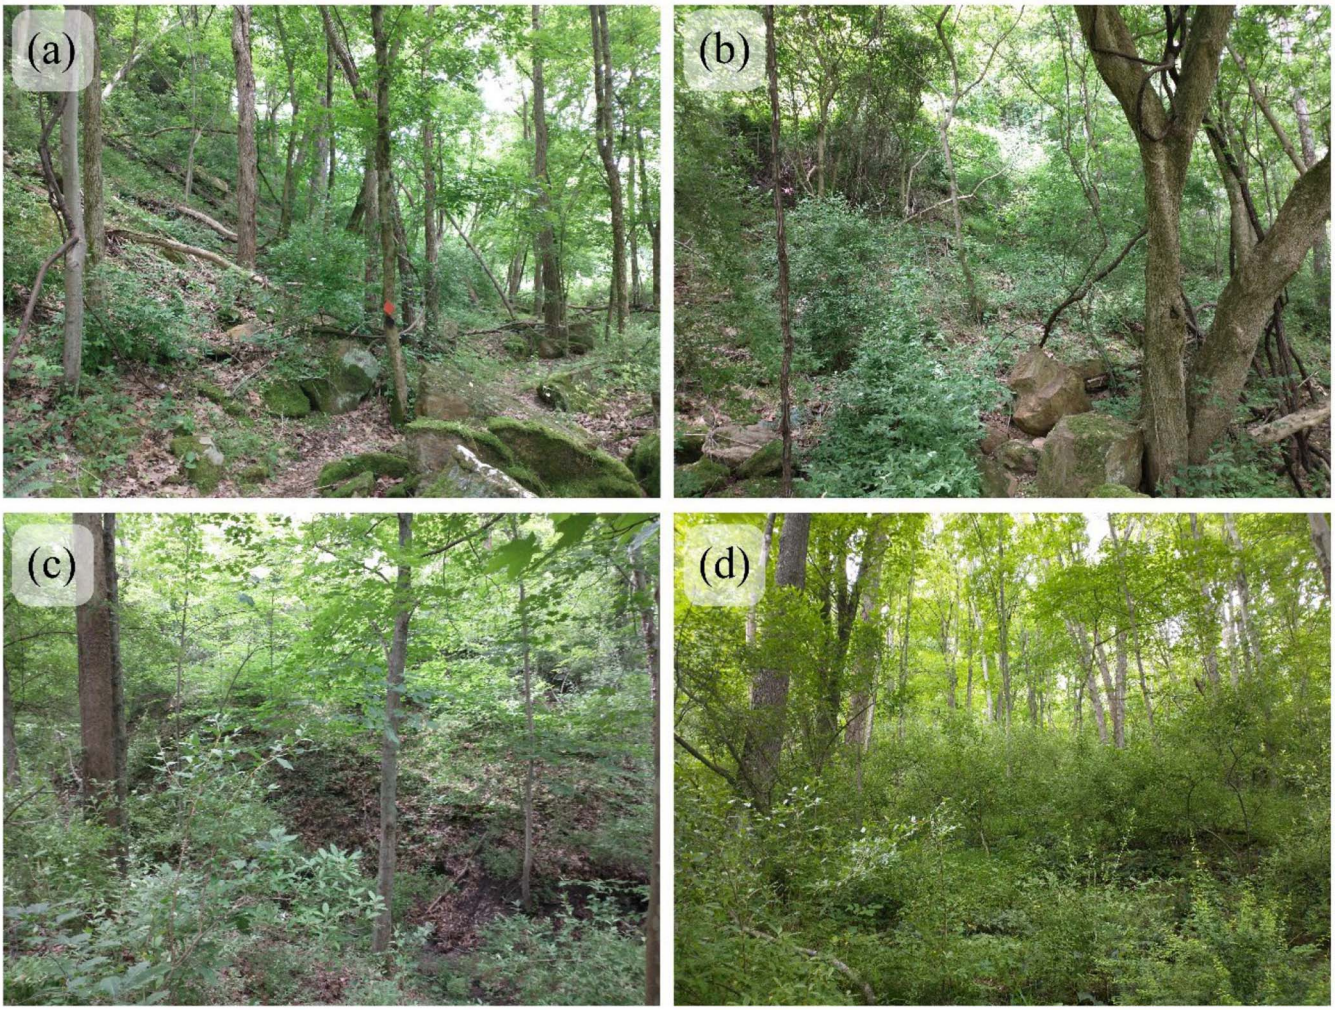
Our interpretations are limited by a lack of *in situ* geotechnical data with which to characterize the mine benches and their adjacent hillslope failures as well as a lack of multi-temporal remote-sensing information with which to establish the timing of hillslope failures. Figures 12 and 13 illustrate the complexity associated with pre-law mining sites and associated hillslope failures. The mine bench is obvious in the lidar-derived hillshade image (Figure 12a). However, it is less obvious in the leaf-off aerial imagery (Figure 12b), other than the lack of woody vegetation on sections of the bench surface. As evident in the hillshade image, downhill creep is noted beneath the bench, suggesting issues of slope instability. Figure 13 shows a series of photos taken at the site and within the extent of the blue box in Figure 12a and b. The first two images (Figure 13a and b) were taken directly beneath the highwall and on the mine bench. The images in Figure 13c and d were taken beneath the mine bench and within the region of lidar-interpreted slope instability. These images highlight the complexity of characterizing hillslope conditions around mine benches, even with site visits, due to vegetation cover. The downhill creep so readily evident in the hillshade image is not easily observable in the field.

Figure 13. Example pre-law mine bench located in Watters Smith Memorial Park in Harrison County, WV. (a, b) Images taken directly below the highwall and on the mine bench within the area highlighted in Figure 12 using the blue box. (c, d) Images showing forested areas downslope from the mine bench, also occurring within the extent highlighted with the blue box in Figure 12, where slope instability was noted based on interpretation of the hillshade data.
